Remnants of Hurricane Ida  
4615DR  
Damage Assessments

New York City Housing Authority  
**MOORE HOUSES**

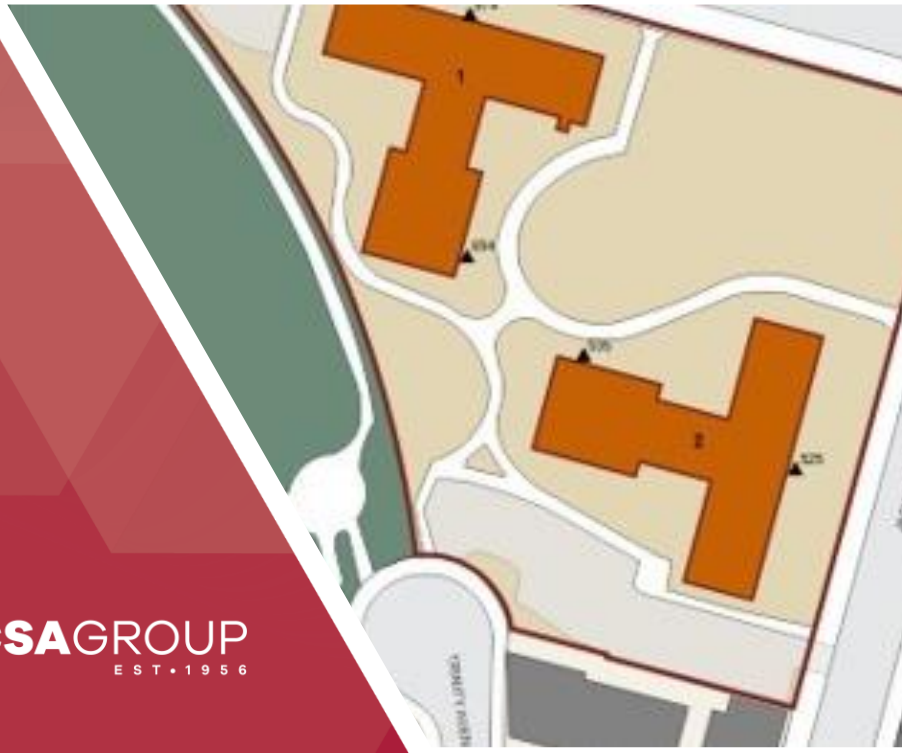
## Table of Contents

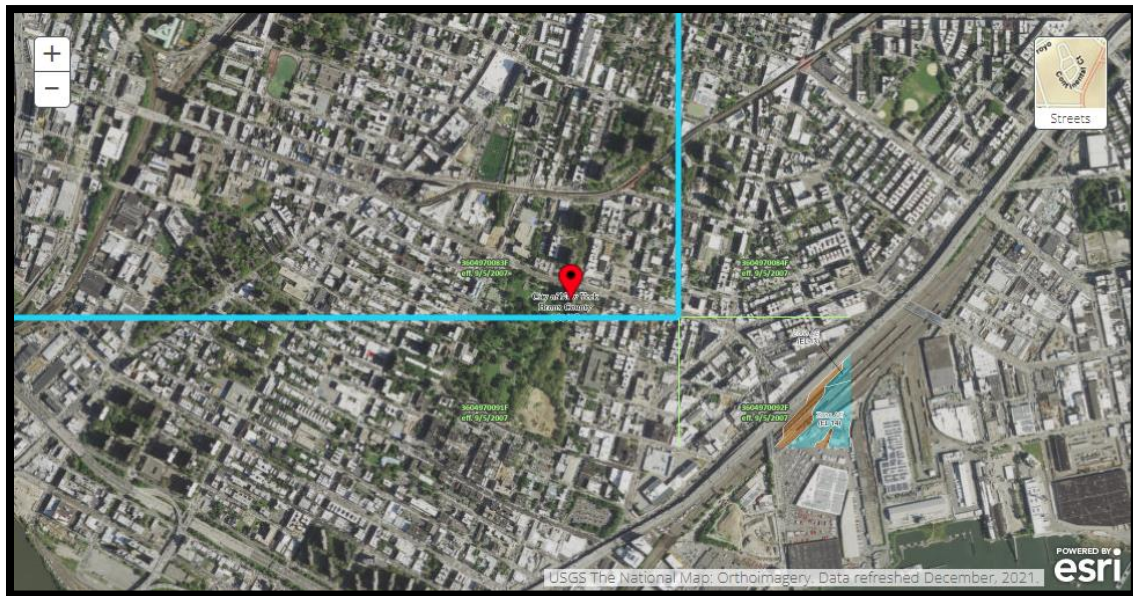
Figure 3. Moore Houses Development FEMA Flood Hazard Map

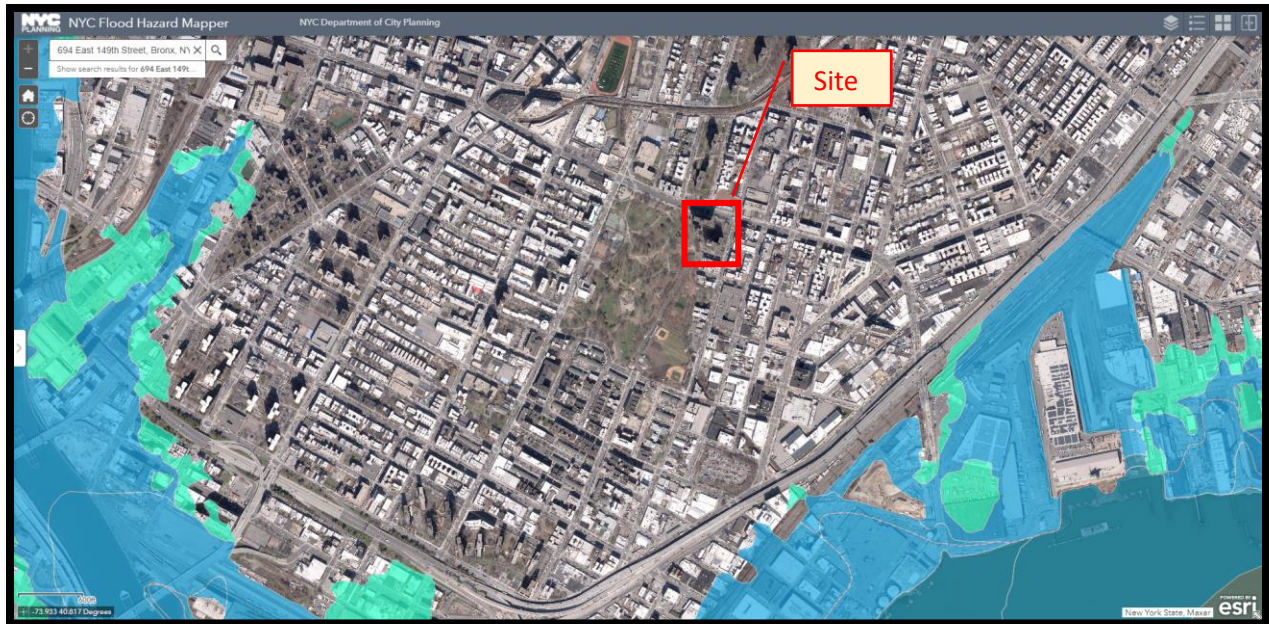
Figure 4. Moore Houses Development NYC Flood Hazard Mapper from NYC Department of City Planning

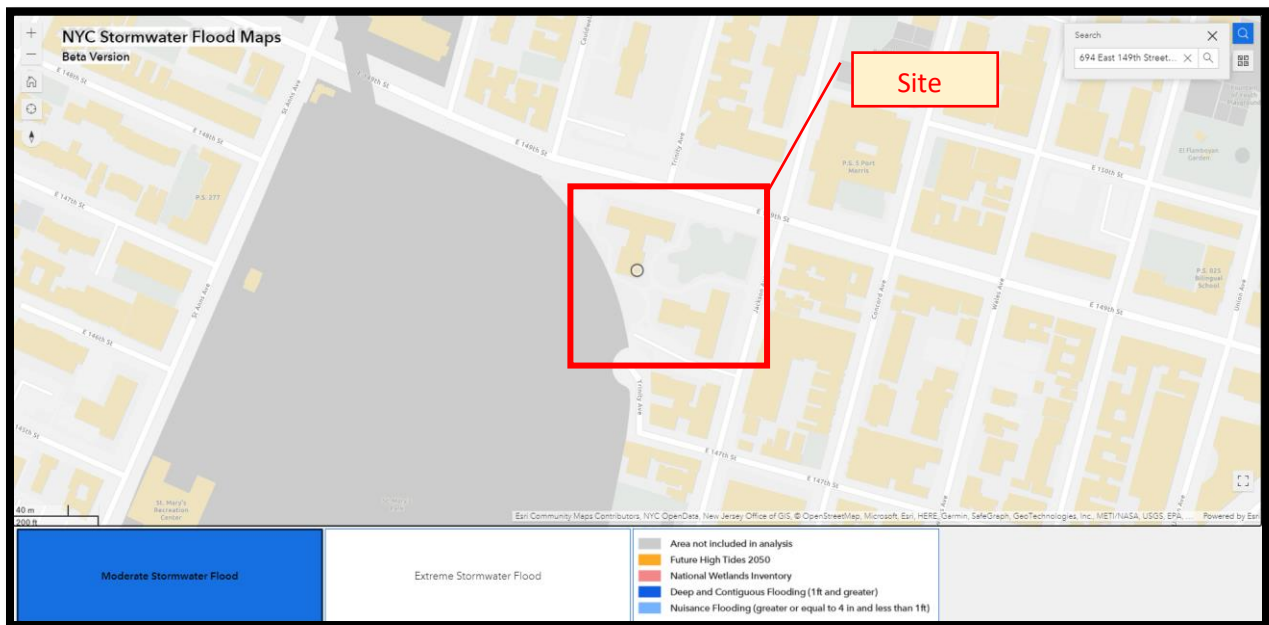
Figure 5. Moore Houses Development NYC Stormwater Flood Maps (Beta Version) for Moderate Stormwater Flood

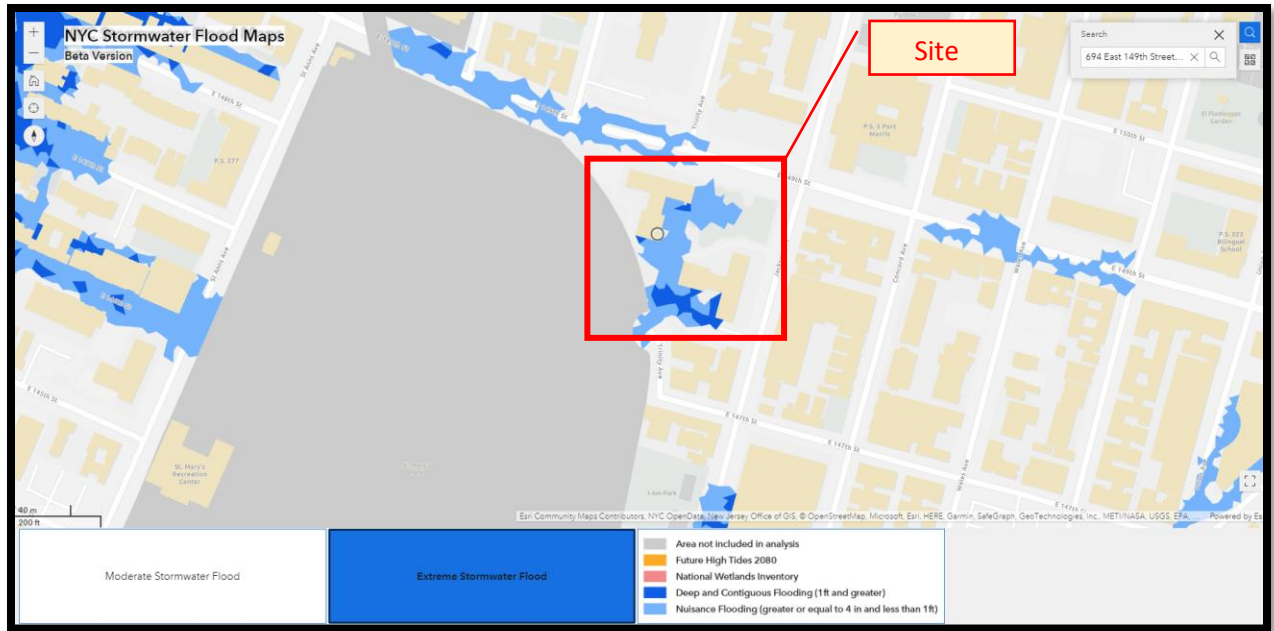
Figure 6. Moore Houses Development NYC Stormwater Flood Maps (Beta Version) for Extreme Stormwater Flood

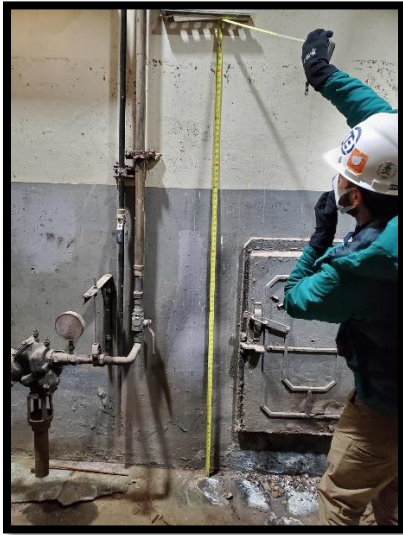
*Photo 1. Moore House Building 1 High Water Mark (approximately 81.25") in Basement after the Storm*

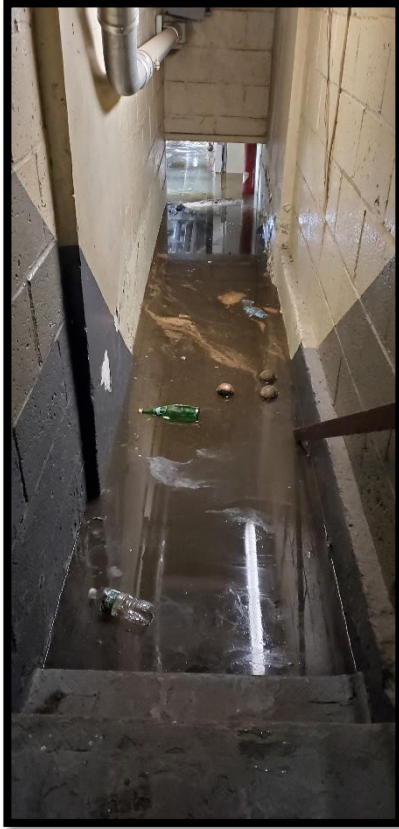
*Photo 7. Moore House Building 1 Flooded Entryway to  
Basement*

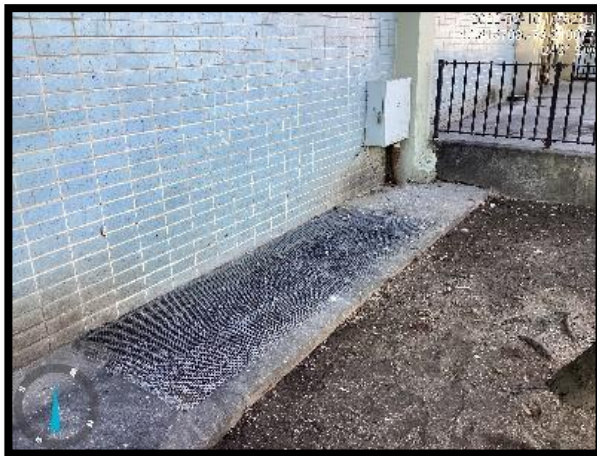
*Photo 8. Entryway During Field Visit*

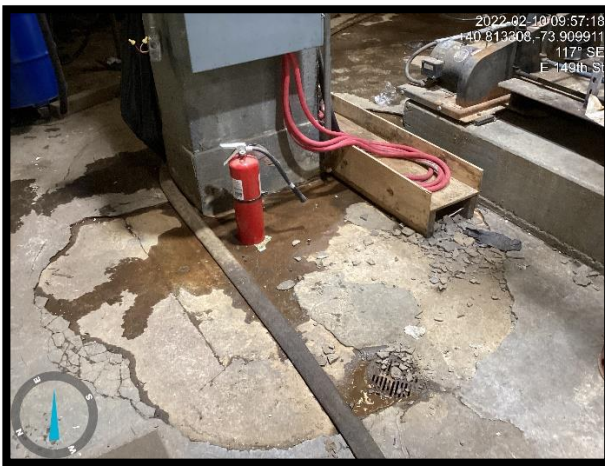
Photo 12. Current Floor Finish Conditions

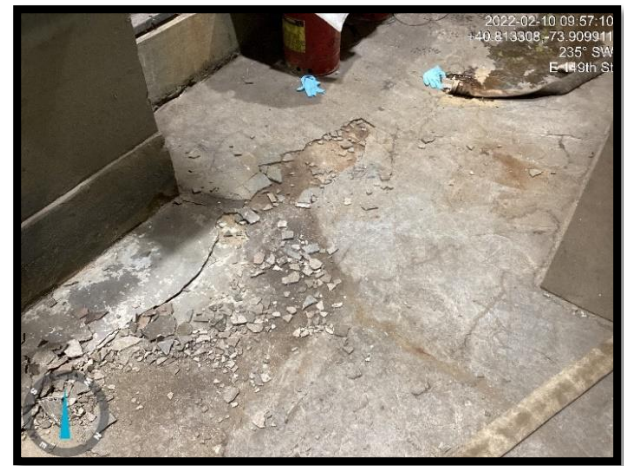
Photo 13. Current Floor Finish Conditions

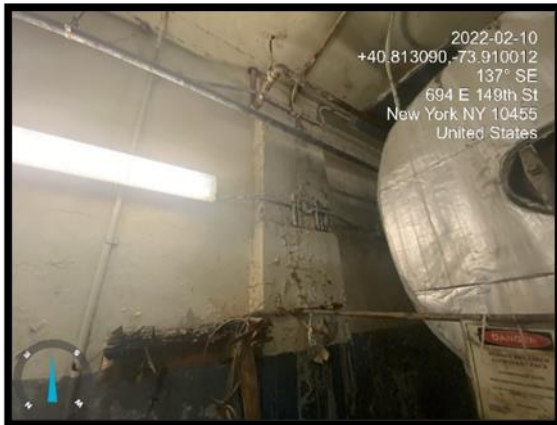
Photo 14. Current Wall Finish Conditions

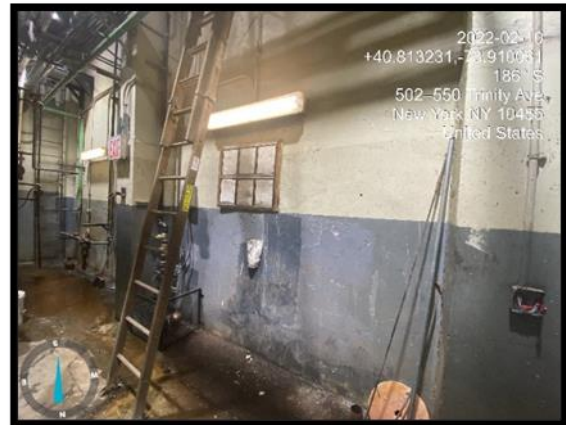
Photo 15. Current Wall Finish Conditions

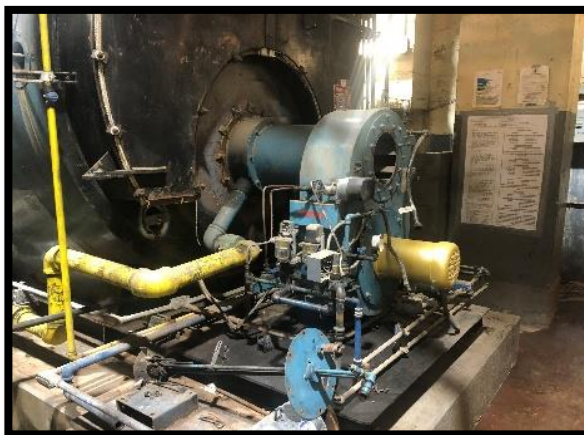
Photo 16. Current Boiler and Burner Assembly

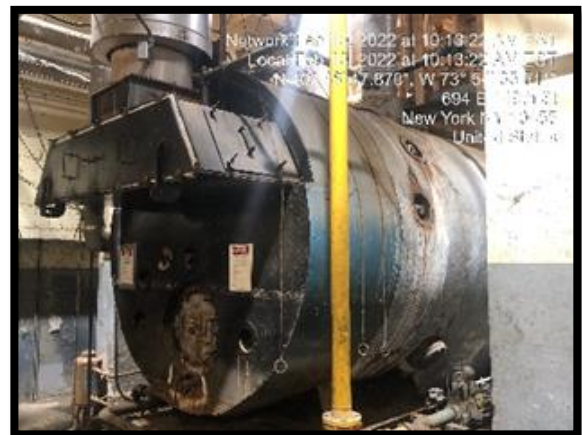
Photo 17. Current Boiler and Burner Assembly

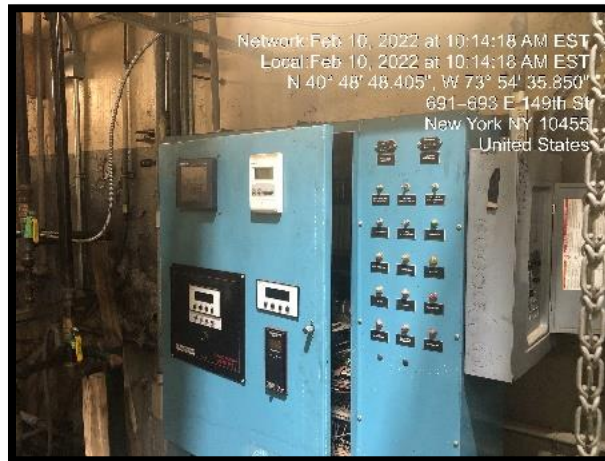
*Photo 18. Boiler Control Panel*

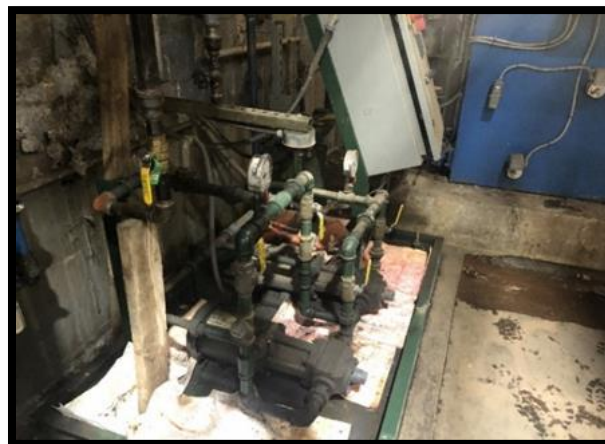
*Photo 19. Fuel Oil Pumping System*

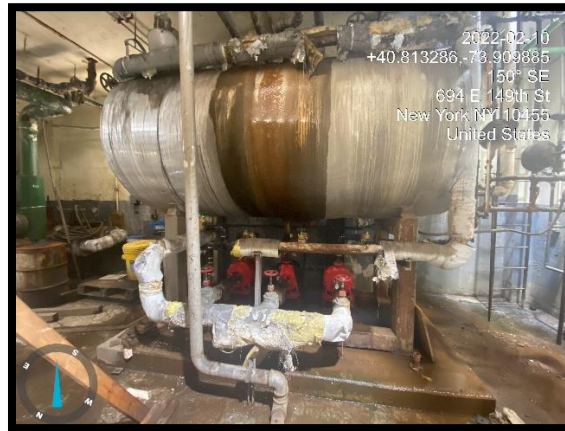
*Photo 20. Feed Water System*

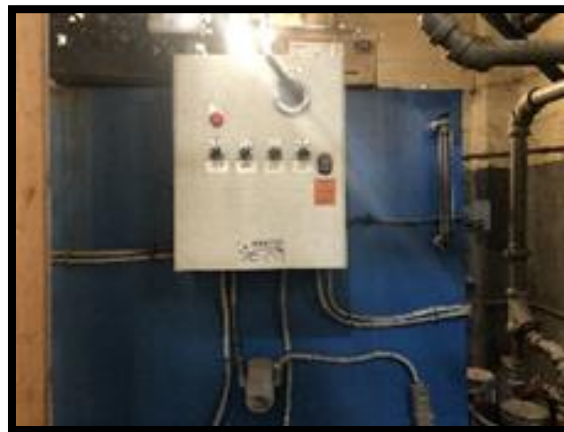
*Photo 21. Vacuum System*

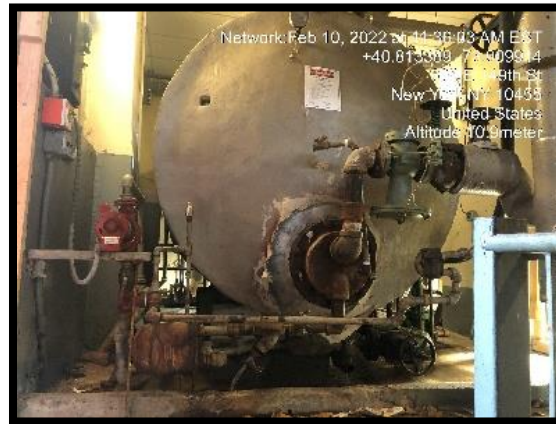
*Photo 22. Domestic Water Storage Tank*

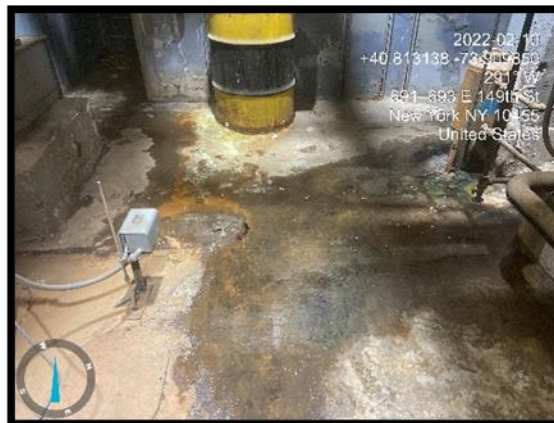
*Photo 23. Sump Pump*

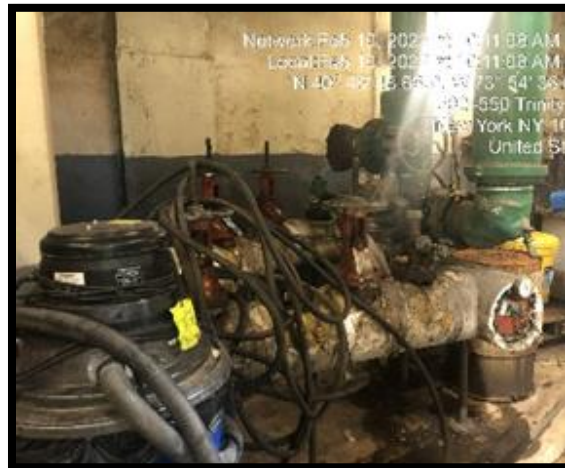
Photo 24. Cold Water Mains

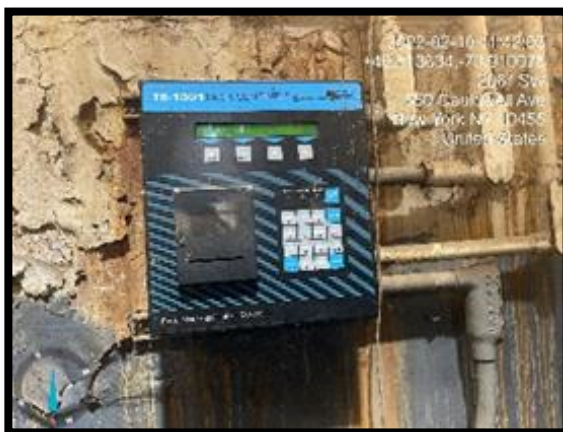
Photo 25. Low Voltage Control Panel

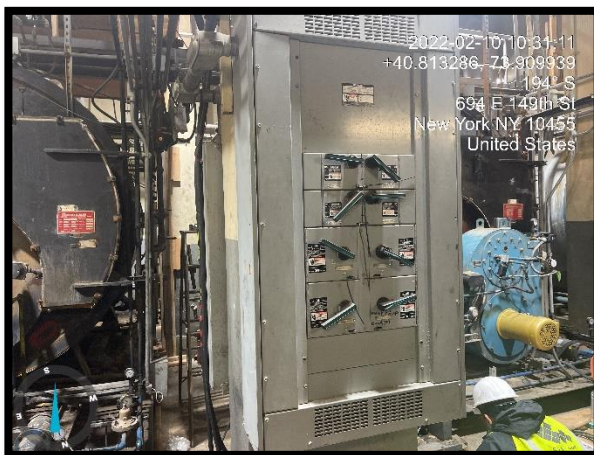
Photo 29. Power Distribution Panel Board

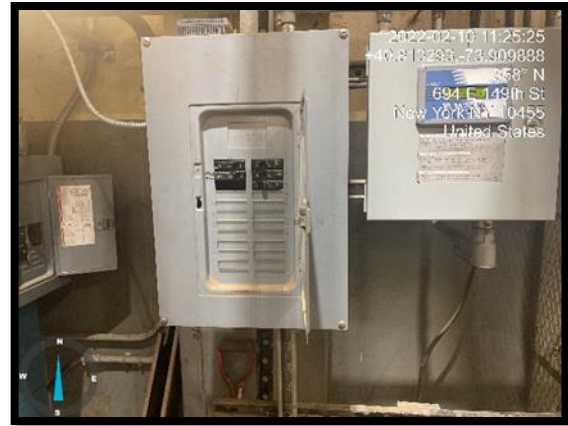
*Photo 32. General Electrical Panel*

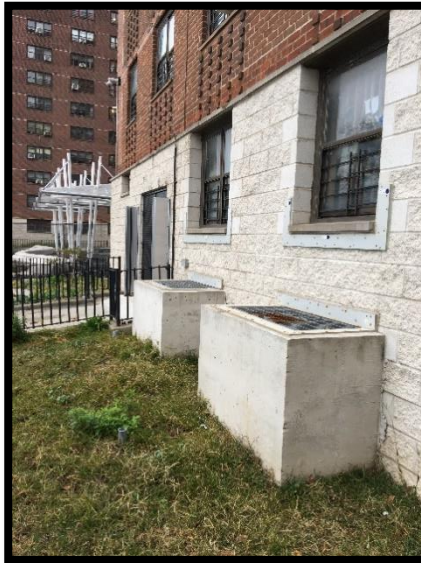
*Photo 34. Flood Protection of Areaways*

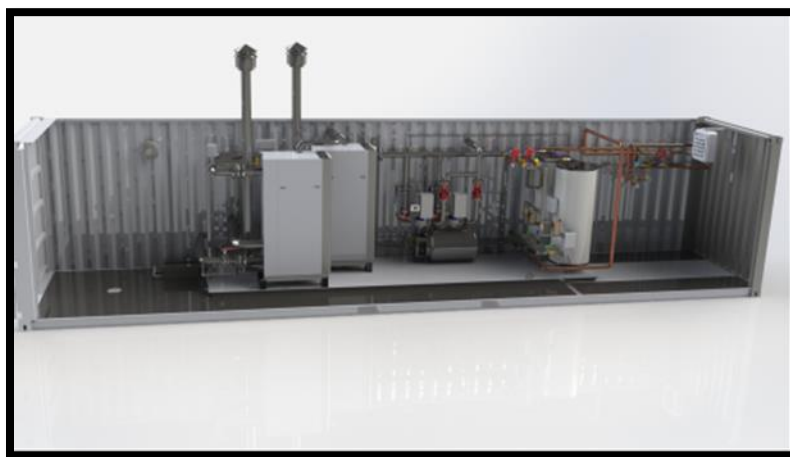
*Photo 35. Hydronic Boiler System Typical Assembly*

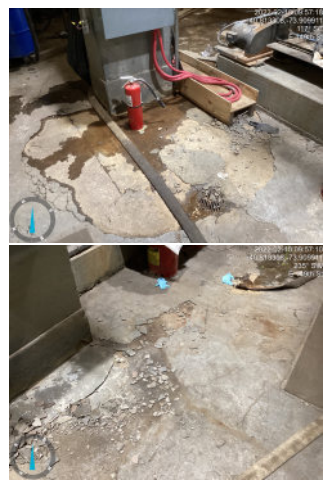
---	--	---------------	-------	--------------------------------------	---	---	---	--

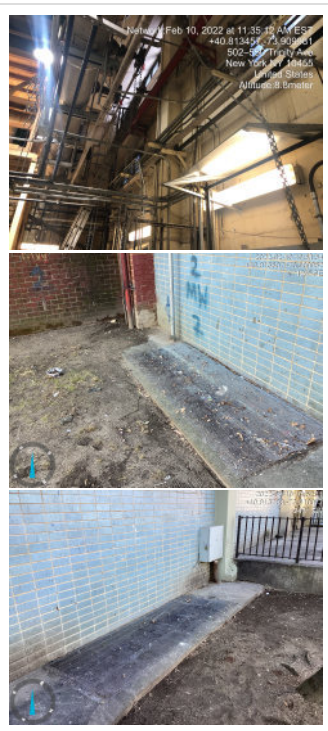
---	--	---------------	-------	--------------------------------------	----------	---	--	---

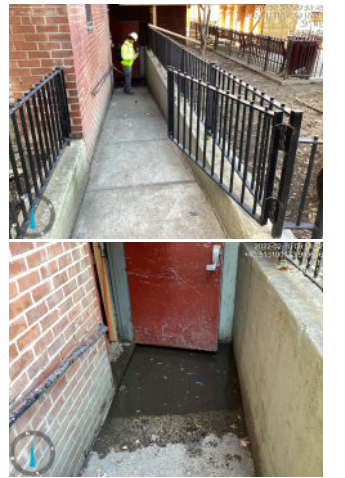
☐	<u>Moore House - Building 1</u>	Architectural	Water Mark	Level: Basement Room: Boiler Room Height: 82 Inches	Watermark evident on boiler tanks, and on exterior walls.	N/A	Entire boiler room submerged during weather event

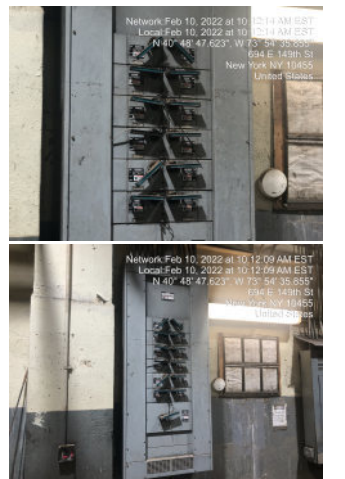
<input type="checkbox"/>	<u>Moore House - Building 1</u>	Electrical	Distribution Panels	Building Face: Front Level: Basement Room: Boiler Room Element Number: 07	6th panel after stair	<b>Complete/Substantial Damaged - Recommend Replacement</b>	Brand Webster Hays Cleveland Div. Of Unicontrol Inc

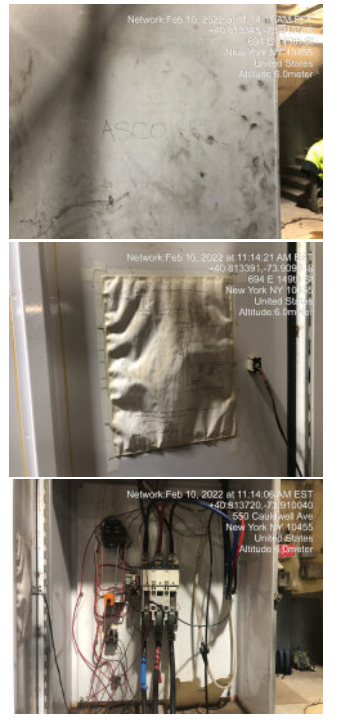
☐	<u>Moore House - Building 1</u>	Electrical	Other	Building Face: Rear Level: Basement Room: Boiler Room Element Number: 10	10th panel after stair	Complete/Substantial Damaged - Recommend Replacement	Brand Lonergan pump system

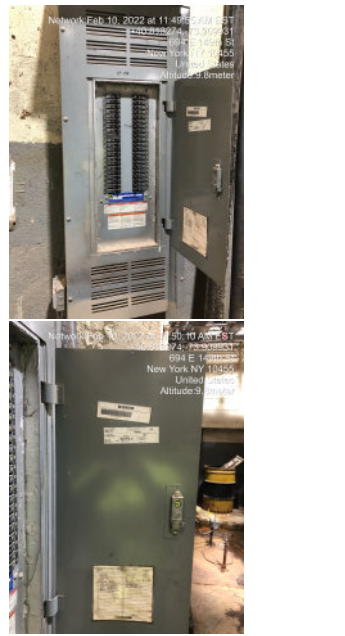
☐	Facility Name	▼ Category	▼ Element	Location Reference	Location Notes (if needed)	Preliminary Assessment - Colorized	Notes	Photo Thumbnails
☐	<a href="#">Moore House - Building 1</a>	Electrical	Panels	Building Face: Front Level: Basement Room: Boiler Room Element Number: 02	3rd panel after stair	<b>Complete/Substantial Damaged - Recommend Replacement</b>	Brand : Webster Opacity Monitor Series 8700

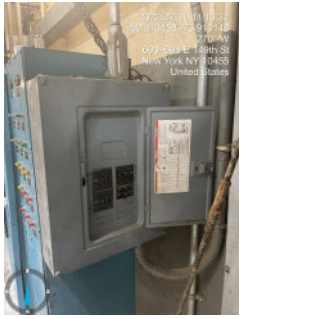
☐	<a href="#">Moore House - Building 1</a>	Electrical	Panels	Level: Basement Room: Boiler Room	Boiler room	<b>Complete/Substantial Damaged - Recommend Replacement</b>	Panels in poor conditions

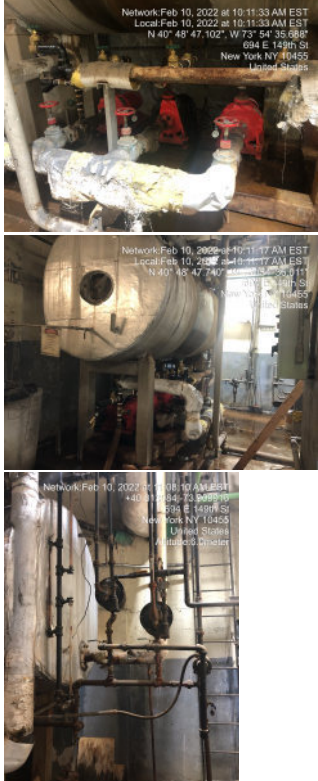
<p>The first photo shows a large, cylindrical tank with significant rust and a large leak of water onto the floor. The second photo shows a similar tank from a different angle, also showing rust and a leak. The third photo shows a complex network of pipes and valves in the boiler room.</p>
<input type="checkbox"/>	<u>Moore House - Building 1</u>	Mechanical	Fuel Oil Pump	Building Face: Rear Level: Sub-basement Room: Boiler Room Quadrant: A3		<b>Damage - Moderate</b>	Fuel oil pumps located in the floor is operating but in poor shape

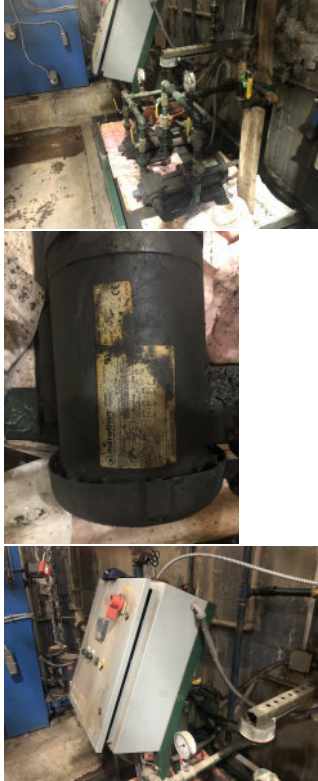
<p>The first photo shows a fuel oil pump with various pipes and valves. The second photo shows a large, cylindrical tank with significant rust and a large leak of water onto the floor. The third photo shows a complex network of pipes and valves in the boiler room.</p>

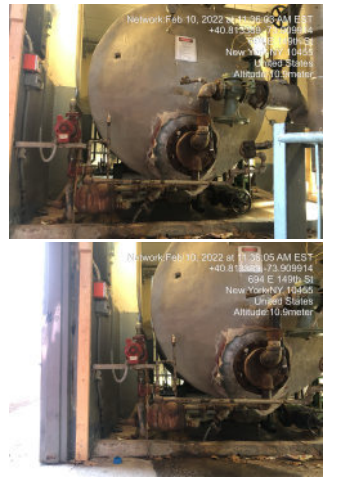
<input type="checkbox"/>	<u>Moore House - Building 1</u>	Plumbing	Hot Water Tank	Building Face: Left Level: Basement Room: Boiler Room	Mezz level of boiler room	<b>Damage - Moderate</b>	Moderate condition. Damage from water seems to be limited to the low lying Piping, traps and insulation

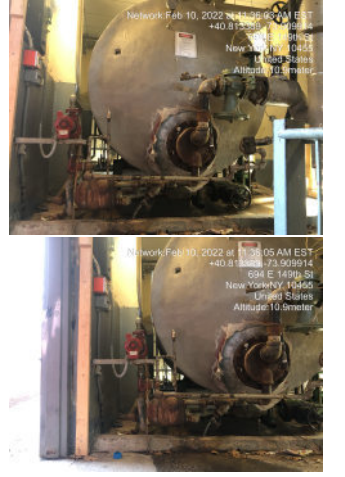
<input type="checkbox"/>	<u>Moore House - Building 1</u>	Plumbing	Hot Water Tank	Level: Basement Room: Boiler Room	Mezz of boiler room	<b>Complete/Substantial Damage - Recommend Replacement</b>	the tank and pumps are all in poor condition and must be replaced. all equipment below the tank was fully submerged.

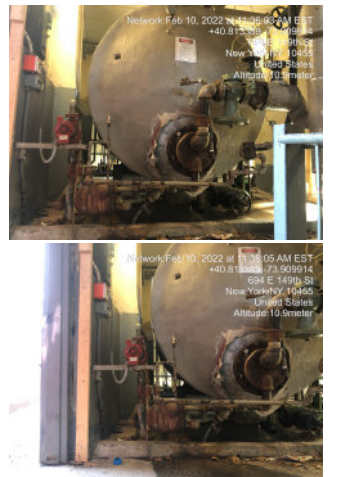
■	Facility Name	▼ Category	▼ Element	Location Reference	Location Notes (if needed)	Preliminary Assessment - Colorized	Notes	Photo Thumbnails
☐	<u>Moore House - Building 1</u>	Structural	Boiler Base/Mount	Level: Basement Room: Boiler Room Element Number: 01	Boiler #1 Located on the left side of the room	Damage - Moderate	Sign of corrosion and deterioration on the boiler skid. It appears that these damages are not associated with the flood event.

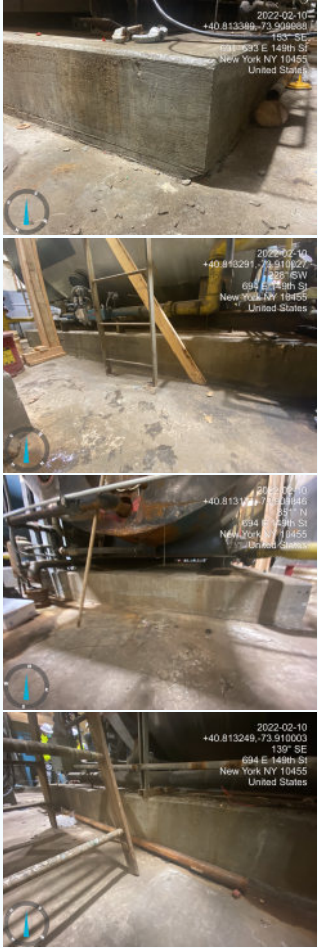
<input type="checkbox"/>	<u>Moore House - Building 1</u>	Structural	Boiler Base/Mount	Level: Basement Room: Boiler Room Element Number: 01	Middle of the room	Damage - Minimum	Minor signs of corrosion on the boiler skid. It appears that these damages are not associated with the flood event.

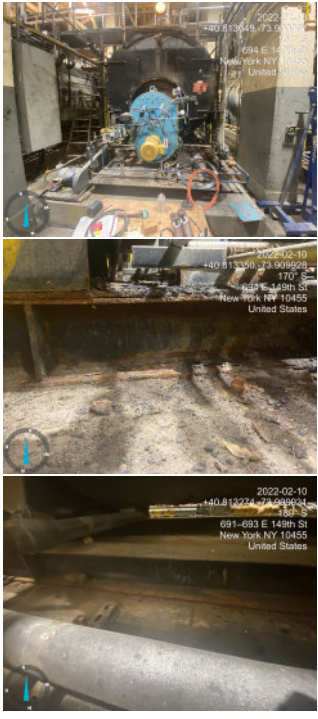
■	Facility Name	▼ Category	▼ Element	Location Reference	Location Notes (if needed)	Preliminary Assessment - Colorized	Notes	Photo Thumbnails
<input type="checkbox"/>	<u>Moore House - Building 1</u>	Structural	Boiler Base/Mount	Level: Basement Room: Boiler Room Element Number: 02	Middle of the room	Damage - Minimum	Boiler Concrete pad shows minor concrete spalls on the sides. It appears that these damages are not associated with the flood event.

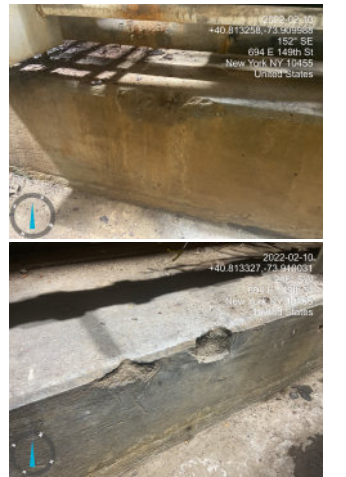
<input type="checkbox"/>	<u>Moore House - Building 1</u>	Structural	Boiler Base/Mount	Level: Basement Room: Boiler Room Element Number: 01	Right side of the room from the entrance	Damage - Minimum	Boiler 3 skid shows minor signs of corrosion. It appears that these damages are not associated with the flood event.

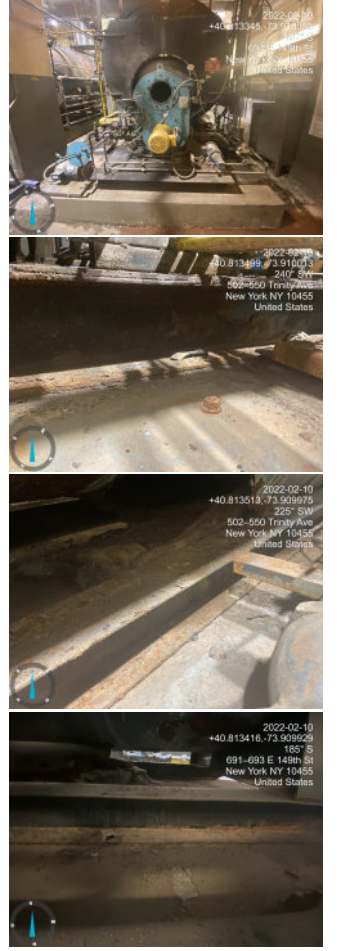
■	Facility Name	▼ Category	▼ Element	Location Reference	Location Notes (if needed)	Preliminary Assessment - Colorized	Notes	Photo Thumbnails
□	<u>Moore House - Building 1</u>	Structural	Boiler Base/Mount	Level: Basement Room: Boiler Room Element Number: 02	Right side of the room from the entrance	Damage - Minimum	Minor concrete cover spall on the side of the concrete pad. It appears that these damages are not associated with the flood event.

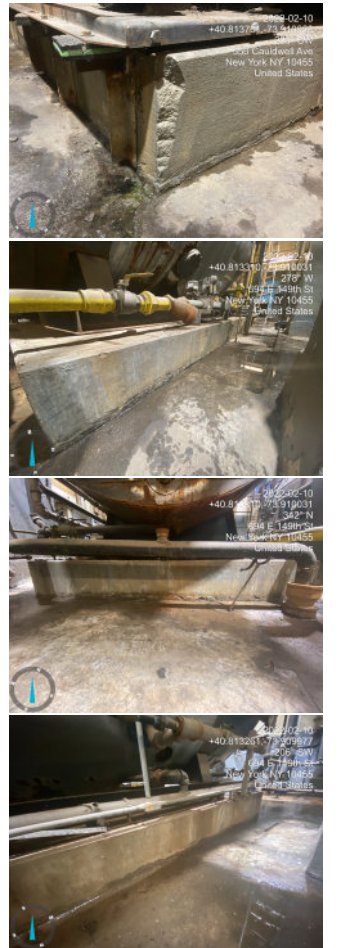
■	Facility Name	▼ Category	▼ Element	Location Reference	Location Notes (if needed)	Preliminary Assessment - Colorized	Notes	Photo Thumbnails
□	<u>Moore House - Building 1</u>	Structural	Floor	Level: Basement Room: Boiler Room Element Number: 01	Floor area	Needs Further Evaluation	The overall condition of the structural floor slab is unknown. The only evidence of deterioration is on the concrete topping ( non structural item) a further investigation needs to be done to determine actual condition of the structural slab.

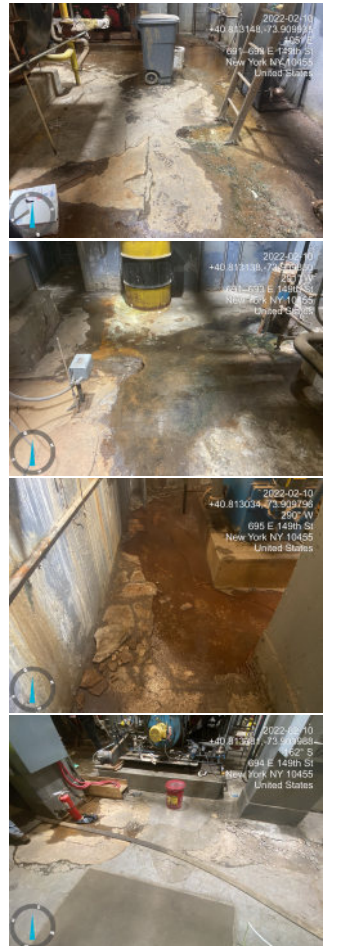
■	Facility Name	▼ Category	▼ Element	Location Reference	Location Notes (if needed)	Preliminary Assessment - Colorized	Notes	Photo Thumbnails
□	<u>Moore House - Building 1</u>	Structural	Other	Level: Basement Room: Boiler Room Element Number: 01	The Boiler feed tank is located below the entrance on the left side of the room.	Damage - Moderate	The steel base of the tank shows a moderate to substantial level of corrosion and deterioration. The concrete pad top surface shows a moderate level of deterioration due to a constant exposure to water coming from the tank. It appears that these damages are not associated with the flood event.

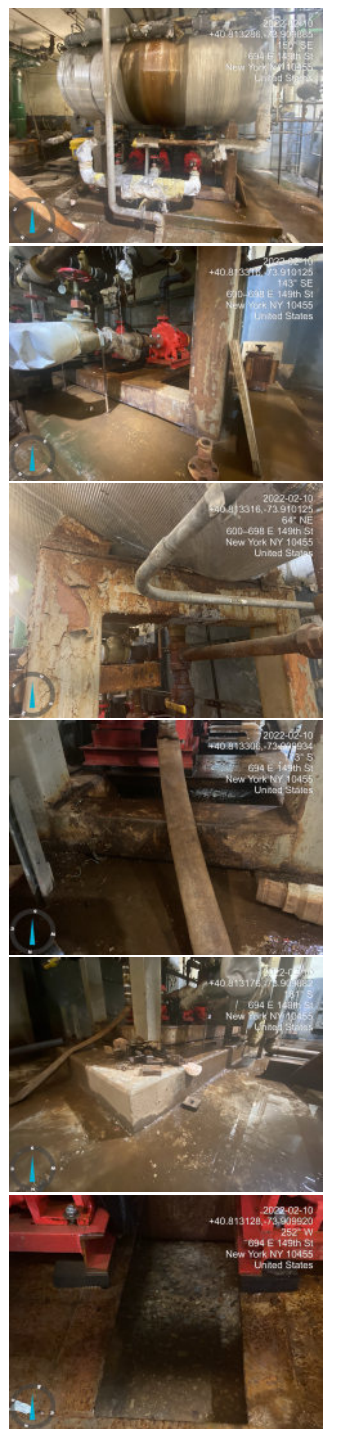
■	Facility Name	▼ Category	▼ Element	Location Reference	Location Notes (if needed)	Preliminary Assessment - Colorized	Notes	Photo Thumbnails
□	<u>Moore House - Building 1</u>	Structural	Walls	Level: Basement Room: Boiler Room Element Number: 01	Structural Wall/Column inside perimeter of the room.	Needs Further Evaluation	The structural wall interior surface shows what appears to be stains, moisture intrusion, mold, calcification and concrete or plaster spalling. The structural system of the wall has to be confirmed with the as built drawings. It appears that these damages are not associated with the flood event.

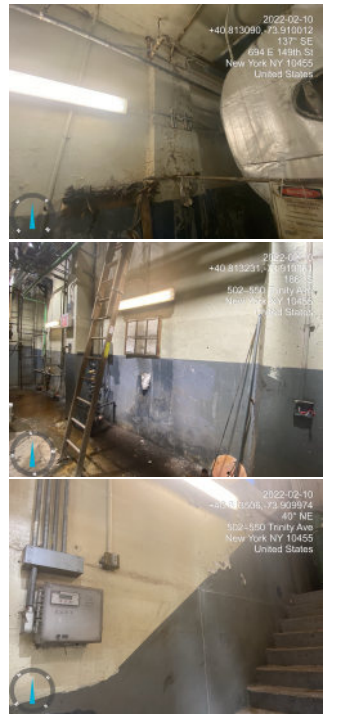
7.2 Appendix 2: ROM Level 5 Cost Estimate for Restoration SOW
